ACKNOWLEDGMENT OF COMPLETION REPORT

BNSF PANHANDLE DERAILMENT WEST OF INTERSECTION U.S. HIGHWAY 60 AND FARM-TO-MARKET 293E SPUR PANHANDLE, CARSON COUNTY, TEXAS

September 2016

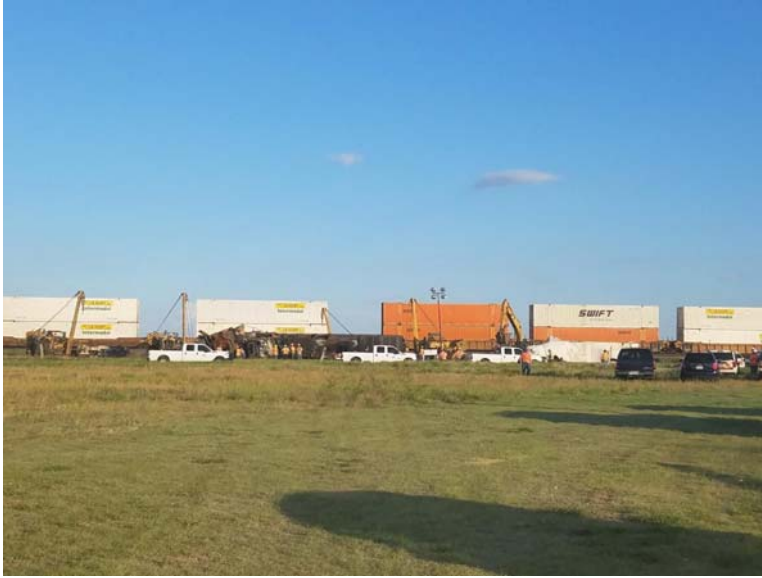
Incident Name: BNSF Train Collision
Event Name: BNSF Train Collision
Photo Type:
Direction:
Photo Name: 20160628_195630.jpg
Date and Time: Jun 28 2016 12:00AM
Latitude: 35.346779
Longitude: -101.368300
Photographer: 11682
Witness: TEDD
Caption: Incident location - West bound railcars

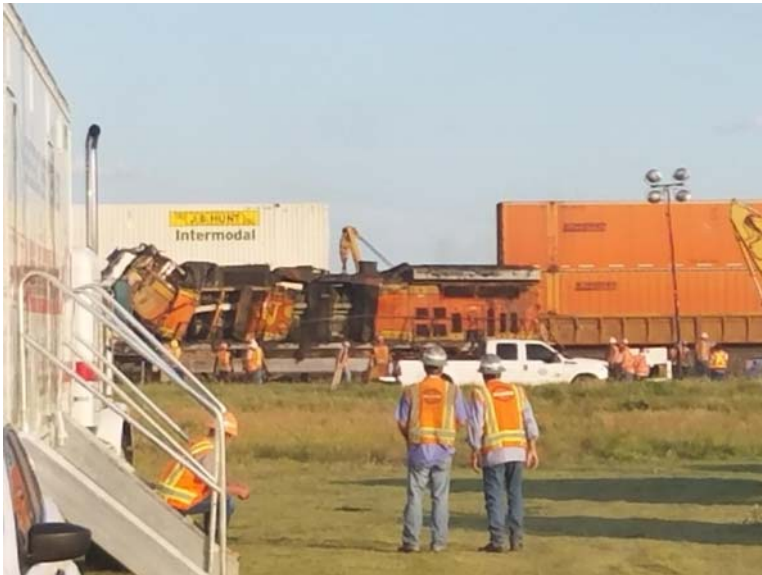
Incident Name: BNSF Train Collision
Event Name: BNSF Train Collision
Photo Type:
Direction:
Photo Name: 20160628_200606.jpg
Date and Time: Jun 28 2016 12:00AM
Latitude: 35.346944
Longitude: -101.368333
Photographer: 11682
Witness: TEDD
Caption: Incident location - West bound engine

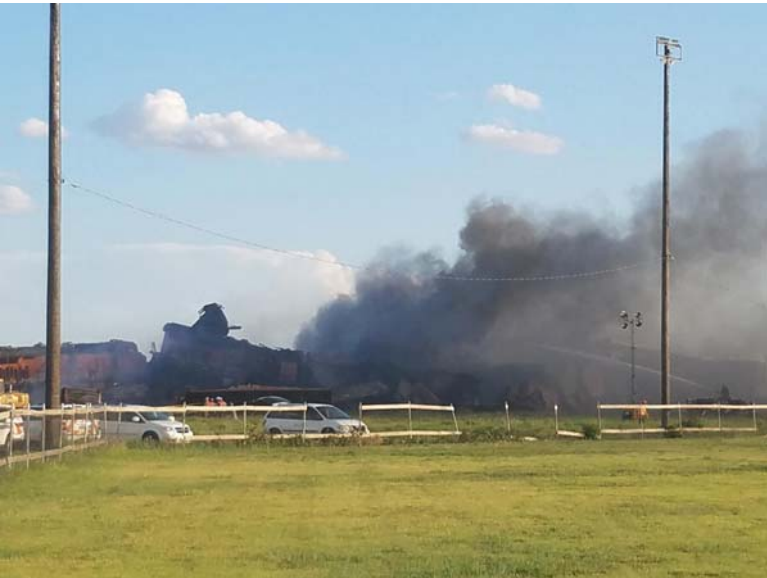
Incident Name: BNSF Train Collision
Event Name: BNSF Train Collision
Photo Type:
Direction:
Photo Name: 20160628_195650.jpg
Date and Time: Jun 28 2016 12:00AM
Latitude: 35.346779
Longitude: -101.368300
Photographer: 11682
Witness: TEDD
Caption: Incident location - Point of impact - Railcars smoldering

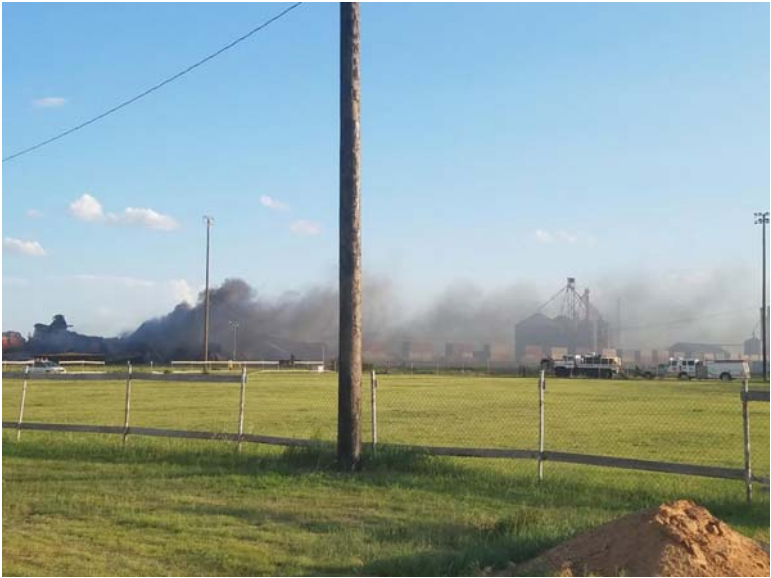
Incident Name: BNSF Train Collision
Event Name: BNSF Train Collision
Photo Type:
Direction:
Photo Name: 20160628_195858.jpg
Date and Time: Jun 28 2016 12:00AM
Latitude: 35.347359
Longitude: -101.368425
Photographer: 11682
Witness: TEDD
Caption: Incident location - Point of impact - Railcars smoldering

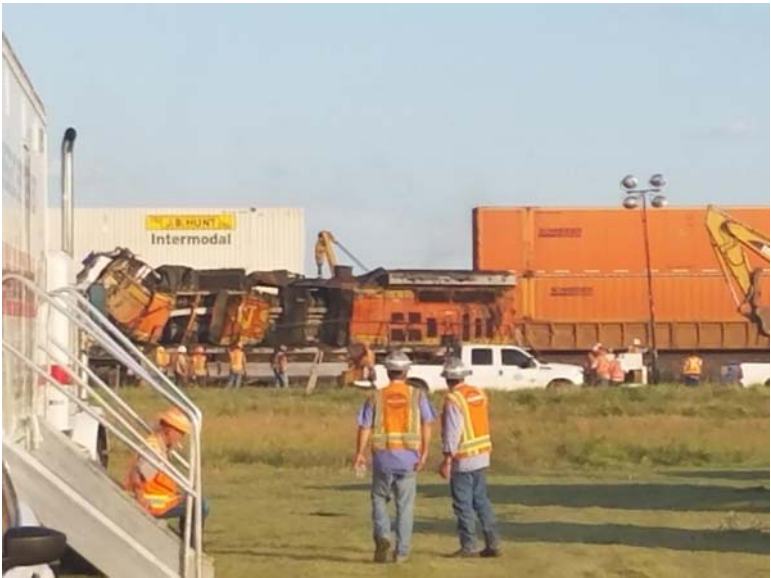
Incident Name: BNSF Train Collision
Event Name: BNSF Train Collision
Photo Type:
Direction:
Photo Name: 20160628_200605.jpg
Date and Time: Jun 28 2016 12:00AM
Latitude: 35.346944
Longitude: -101.368333
Photographer: 11682
Witness: TEDD
Caption: Incident location - West bound engine

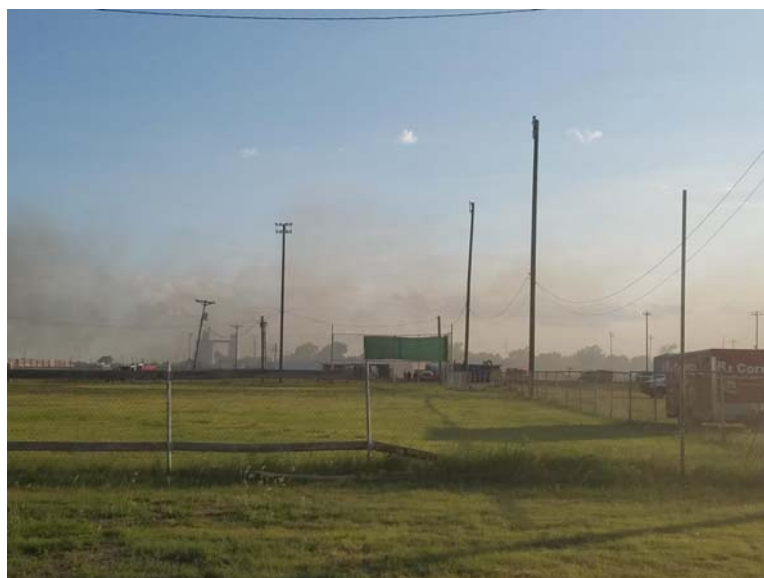
Incident Name:	BNSF Train Collision
Event Name:	BNSF Train Collision
Photo Type:	
Direction:	
Photo Name:	20160628_195938.jpg
Date and Time:	Jun 28 2016 12:00AM
Latitude:	35.347359
Longitude:	-101.368425
Photographer:	11682
Witness:	TEDD
Caption:	Incident location - Smoke migrating north-northwest

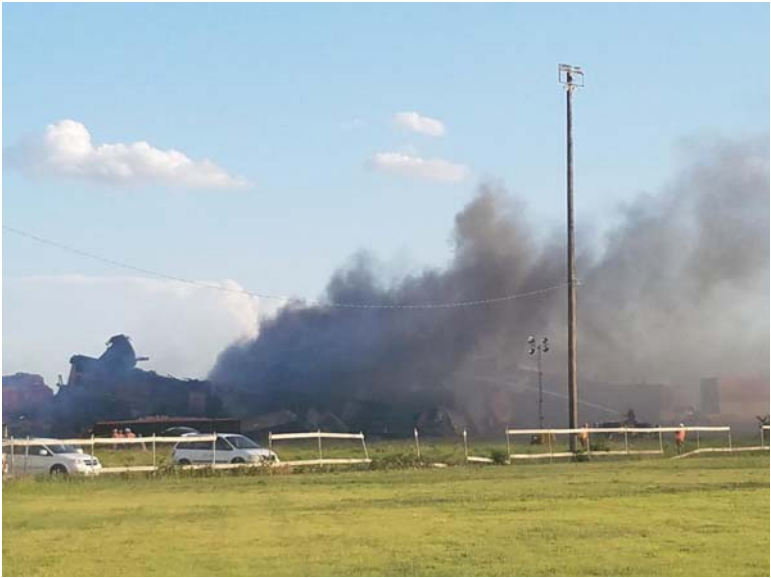
Incident Name: BNSF Train Collision
Event Name: BNSF Train Collision
Photo Type:
Direction:
Photo Name: 20160628_195652.jpg
Date and Time: Jun 28 2016 12:00AM
Latitude: 35.346779
Longitude: -101.368300
Photographer: 11682
Witness: TEDD
Caption: Incident location - Point of impact - Railcars smoldering

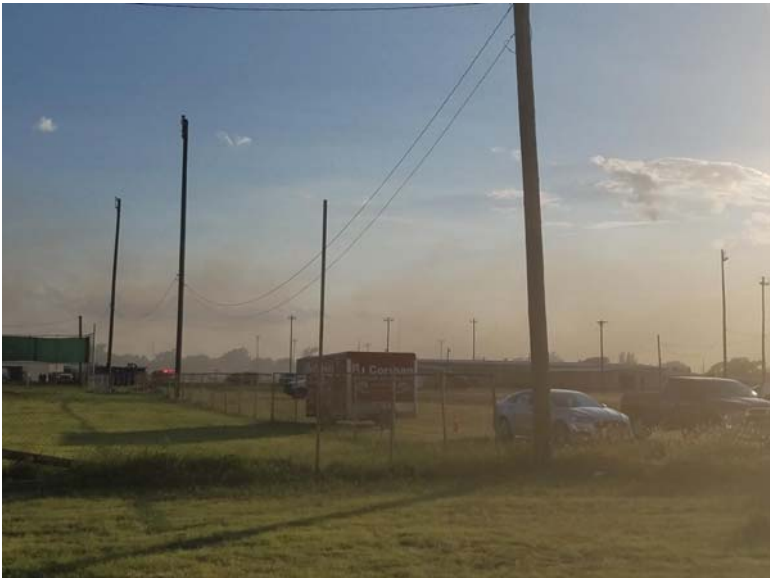
Incident Name: BNSF Train Collision
Event Name: BNSF Train Collision
Photo Type:
Direction:
Photo Name: 20160628_195939.jpg
Date and Time: Jun 28 2016 12:00AM
Latitude: 35.347359
Longitude: -101.368425
Photographer: 11682
Witness: TEDD
Caption: Incident location - Smoke migrating north-northwest

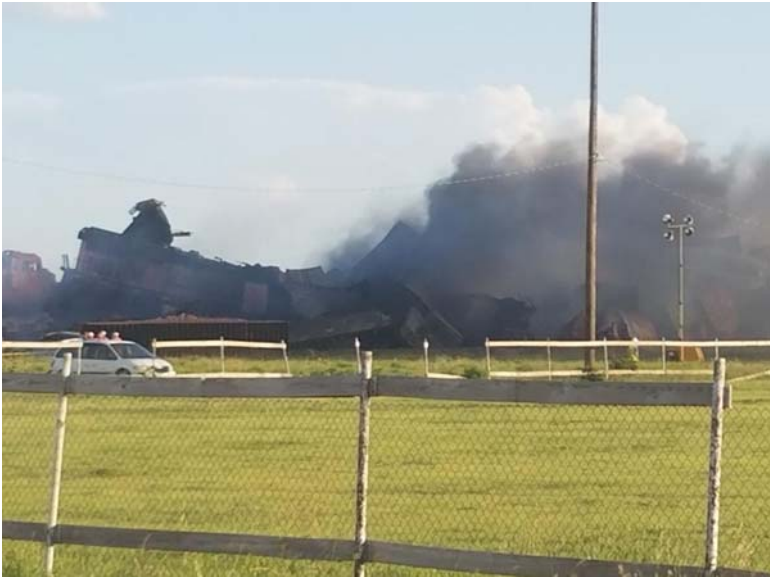
Incident Name: BNSF Train Collision
Event Name: BNSF Train Collision
Photo Type:
Direction:
Photo Name: 20160628_195850.jpg
Date and Time: Jun 28 2016 12:00AM
Latitude: 35.347222
Longitude: -101.368333
Photographer: 11682
Witness: TEDD
Caption: Incident location - Point of impact - Railcars smoldering

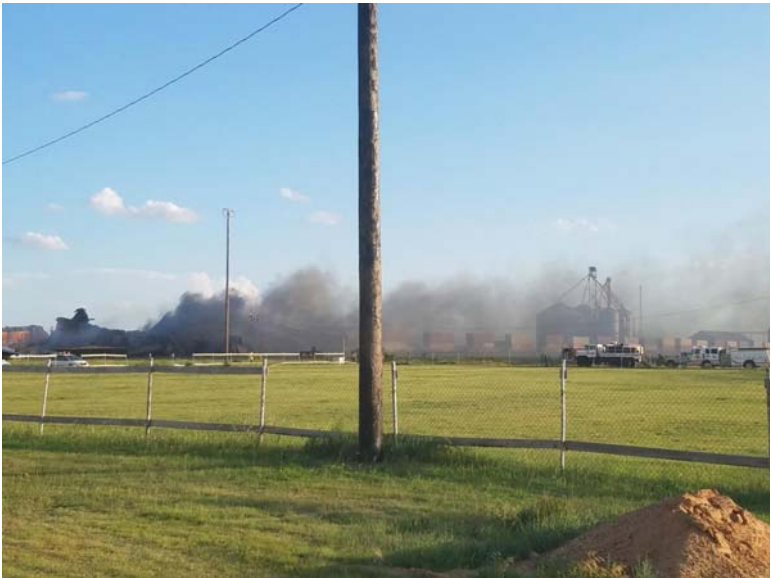
Incident Name: BNSF Train Collision
Event Name: BNSF Train Collision
Photo Type:
Direction:
Photo Name: 20160628_195857.jpg
Date and Time: Jun 28 2016 12:00AM
Latitude: 35.347359
Longitude: -101.368425
Photographer: 11682
Witness: TEDD
Caption: Incident location - Point of impact - Railcars smoldering

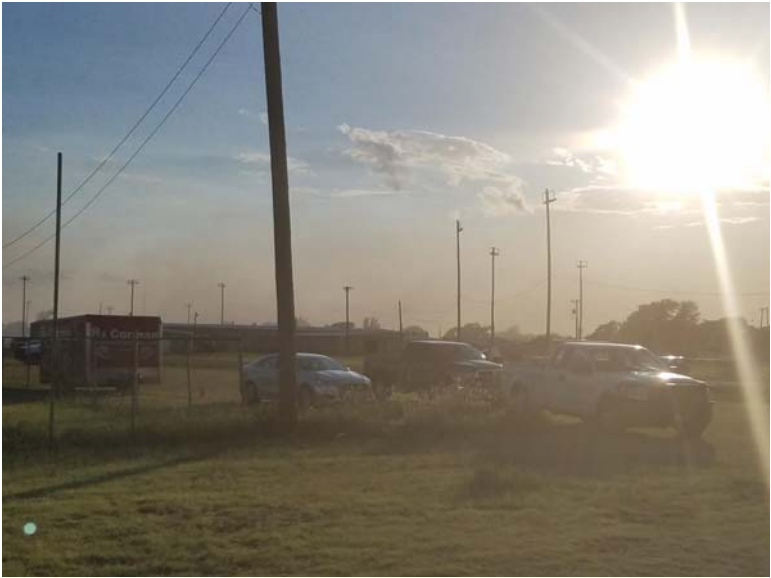
Incident Name: BNSF Train Collision
Event Name: BNSF Train Collision
Photo Type:
Direction:
Photo Name: 20160628_195941.jpg
Date and Time: Jun 28 2016 12:00AM
Latitude: 35.347359
Longitude: -101.368425
Photographer: 11682
Witness: TEDD
Caption: Incident location - Smoke migrating north-northwest

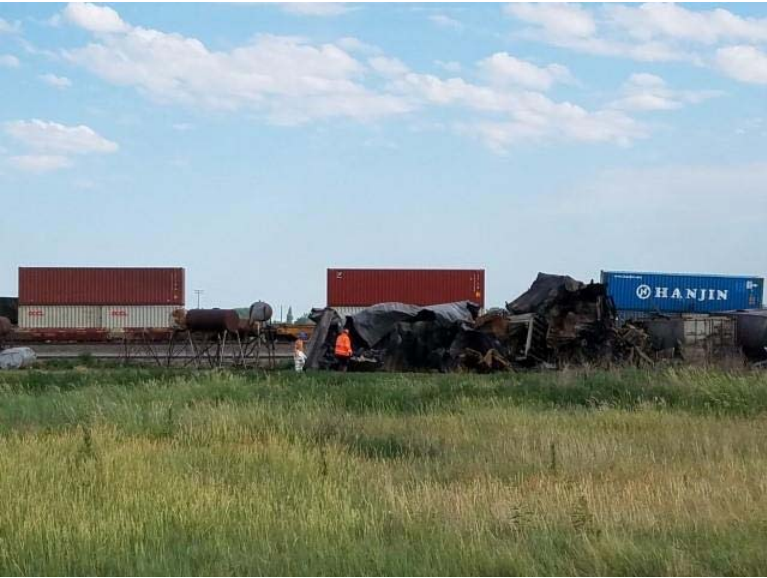
Incident Name: BNSF Train Collision
Event Name: BNSF Train Collision
Photo Type:
Direction:
Photo Name: 20160629_094052.jpg
Date and Time: Jun 29 2016 12:00AM
Latitude: 35.345581
Longitude: -101.366038
Photographer: 11682
Witness: TEDD
Caption: Point of Impact - East Bound Train

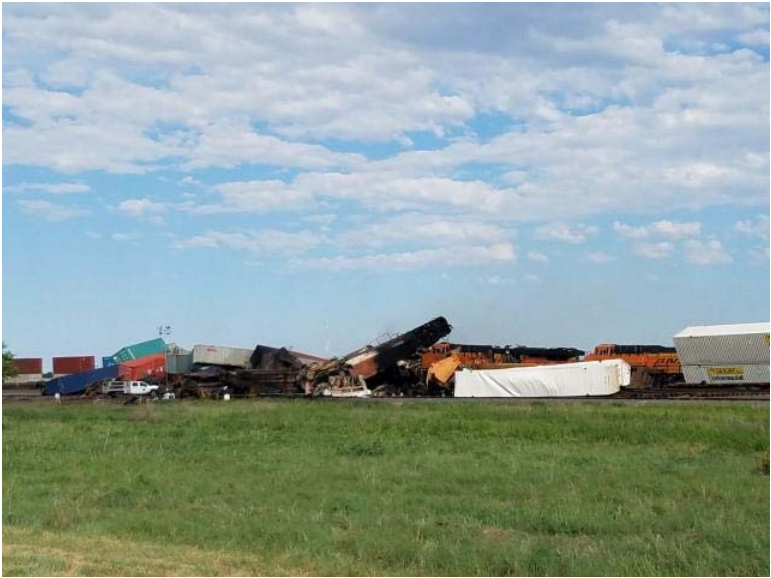
Incident Name: BNSF Train Collision
Event Name: BNSF Train Collision
Photo Type:
Direction:
Photo Name: 20160629_094033.jpg
Date and Time: Jun 29 2016 12:00AM
Latitude: 35.345581
Longitude: -101.366038
Photographer: 11682
Witness: TEDD
Caption: Point of Impact - West Bound Train

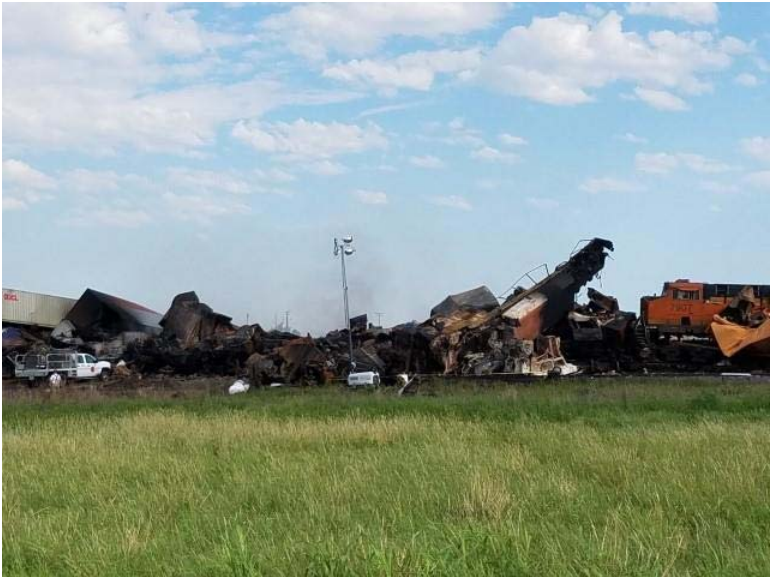
Incident Name: BNSF Train Collision
Event Name: BNSF Train Collision
Photo Type:
Direction:
Photo Name: 20160629_094041.jpg
Date and Time: Jun 29 2016 12:00AM
Latitude: 35.345581
Longitude: -101.366038
Photographer: 11682
Witness: TEDD
Caption: Point of Impact

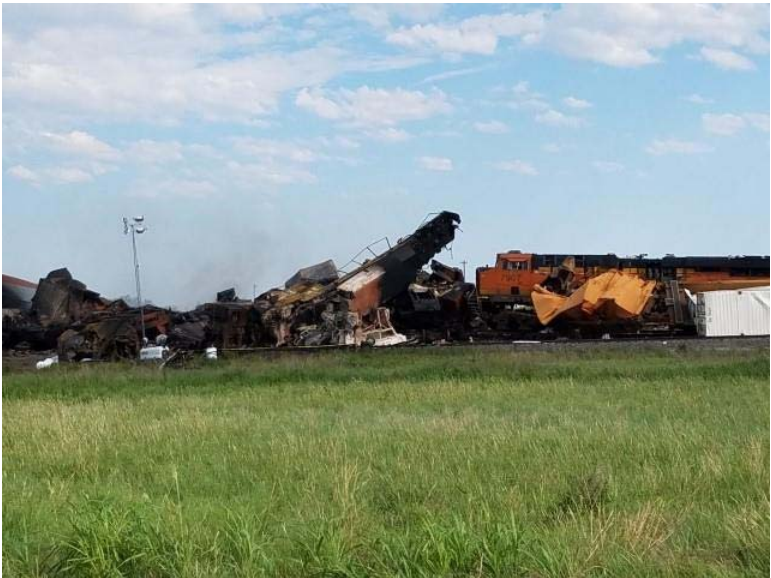
Incident Name: BNSF Train Collision
Event Name: BNSF Train Collision
Photo Type:
Direction:
Photo Name: 20160629_094040.jpg
Date and Time: Jun 29 2016 12:00AM
Latitude: 35.345581
Longitude: -101.366038
Photographer: 11682
Witness: TEDD
Caption: Point of Impact - West Bound Train

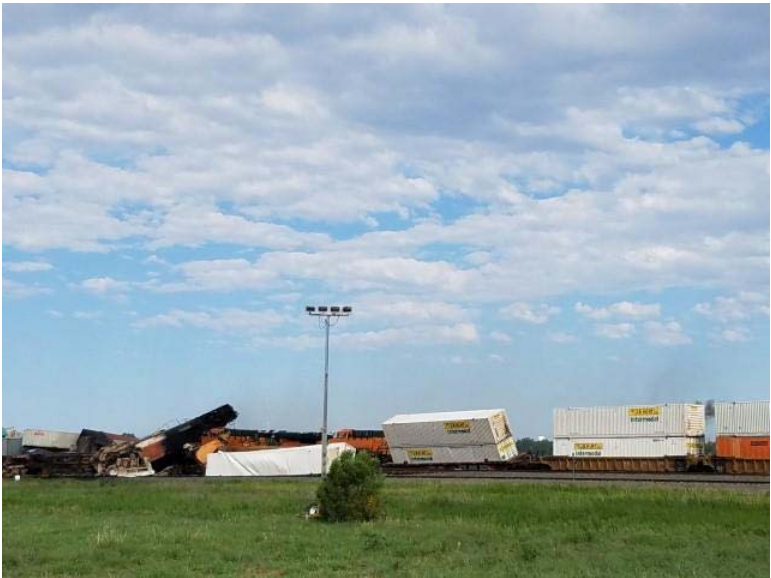
Incident Name: BNSF Train Collision
Event Name: BNSF Train Collision
Photo Type:
Direction:
Photo Name: 20160629_094032.jpg
Date and Time: Jun 29 2016 12:00AM
Latitude: 35.345581
Longitude: -101.366038
Photographer: 11682
Witness: TEDD
Caption: Point of Impact - West Bound Train

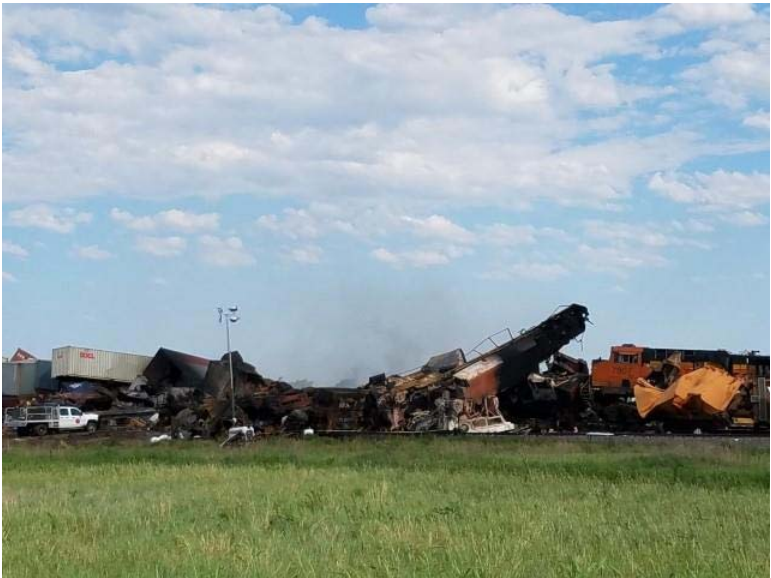
Incident Name: BNSF Train Collision
Event Name: BNSF Train Collision
Photo Type:
Direction:
Photo Name: 20160629_094039.jpg
Date and Time: Jun 29 2016 12:00AM
Latitude: 35.345581
Longitude: -101.366038
Photographer: 11682
Witness: TEDD
Caption: Point of Impact - West Bound Train
